Manhole Inspection Summary

Manhole # S27Y__012MH

Insp Date: 1/14/09 9:48 AM

Location Address: **Annapolis Rd.**

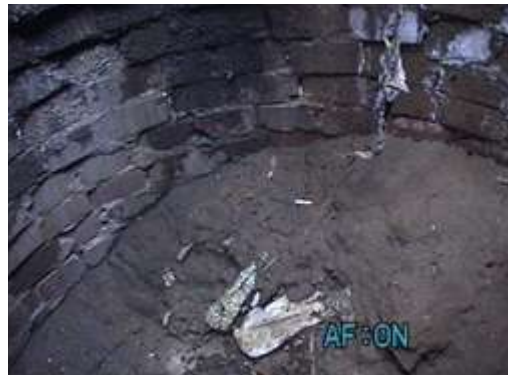
Defect 4

Infiltration: ☐ None ☐ Joint ☒ **Cracks** ☒ **Mortar** ☐ Roots ☐ Wall

barrel infiltration at cracks & mortar

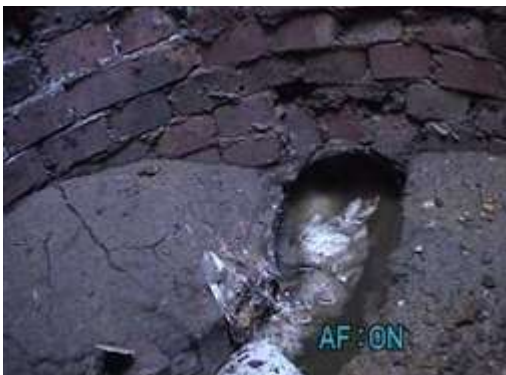
Defect 3

Condition: ☐ Sound ☒ **Cracked** ☐ Root Intrusion ☒ **Loose Brick** ☒ **Deteriorated**

Condition: ☐ Sound ☐ Cracked ☐ Root Intrusion ☐ Deteriorated ☐ Leaks ☒ **Debris**

channel & bench debris, cracked & deteriorated barrel with loose/missing bricks

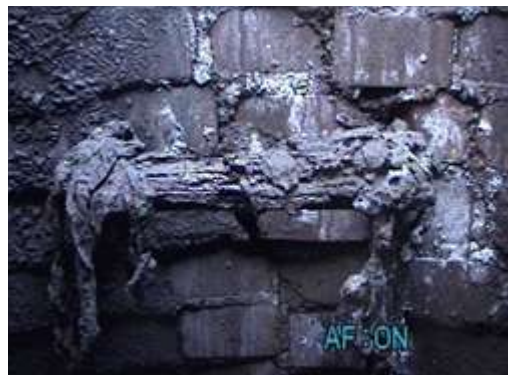
Defect 2

Steps Count: **1** Missing: **0** ☒ **Corroded**

Surcharge ☒ **Evidence Of Surcharge** Depth: **2** (ft.) ☐ Active Surcharge Present

corroded rung with surcharge

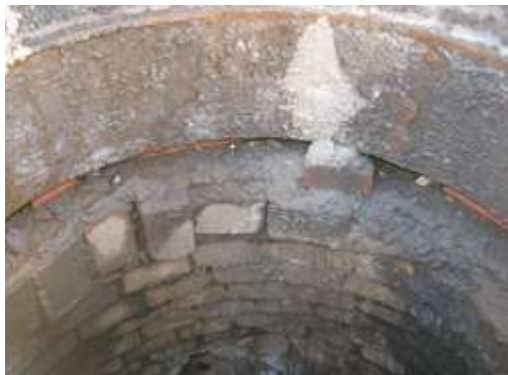
Defect 1

Frame Offset: **3** (in.) Condition: ☒ Sound ☐ Cracked ☐ Leaks

Condition: ☐ Sound ☐ Cracked ☐ Root Intrusion ☒ **Loose Brick** ☒ **Deteriorated**

Infiltration: ☐ None ☒ **Joint** ☐ Cracks ☒ **Mortar** ☐ Roots ☐ Wall

frame offset, chimney deteriorated &
loose brick with infiltration from joint &
mortar

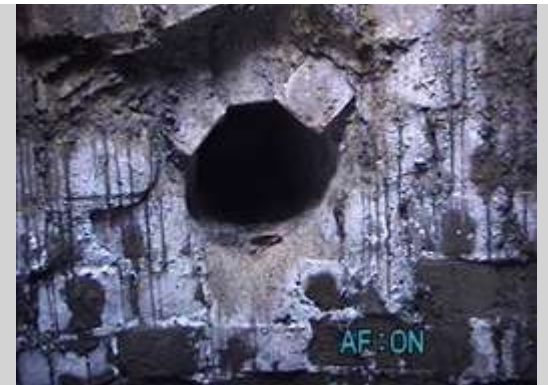
8 O'Clock Inflow

Deposits: ☐ None ☐ Mud ☐ Sludge ☒ Debris ☐ Grease

Silt Depth: 3 (in.) Deposits Extent: Medium
